Manhole Inspection Summary

Manhole # S23EE1002MH

Insp Date: **3/15/07 1:10 PM**

Location Address: **1401 41St ST**

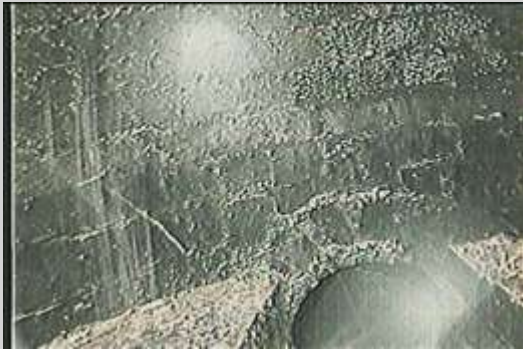
12 in. Circular Gravity Sewer Pipe Out @ 12 O'Clock

Pipe Material: **Clay** ☐ Pipe Lined

Invert Depth: **18.86** (ft.) Flow Characteristics: **Fast**

Infiltration: **None** Pipe Seal Cond: **Unknown**

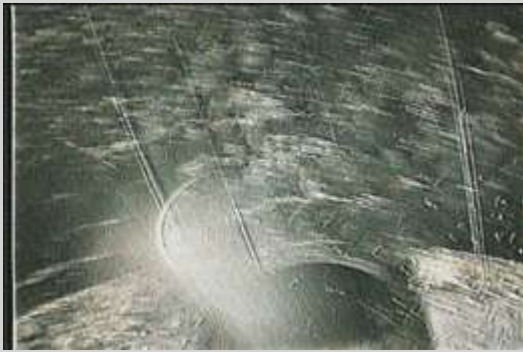
12 in. Circular Gravity Sewer

Pipe Material: **Clay** ☐ Pipe Lined

Infiltration: **None** Pipe Seal Cond: **Unknown**
